# Residential Inspection Report

1234 Your Street  
City, OH 12345-

Prepared for: Ryan Fisher

Prepared by: Arrow Inspection Services, LLC  
648 School Avenue  
Cuyahoga Falls, OH 44221

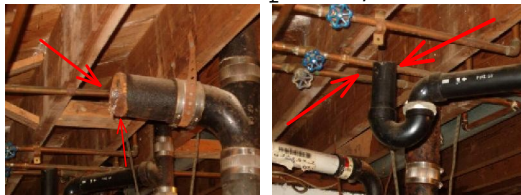
- 4.      **Drain Pipes:** Cast iron A licensed plumber is recommended to evaluate and estimate repairs, needs hangers on pvc drain pipe

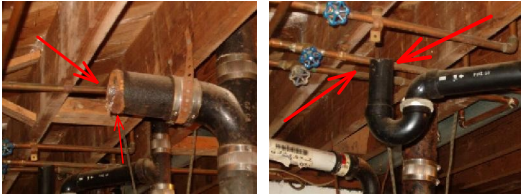
34. **Drain Pipes:** Cast iron A licensed plumber is recommended to evaluate and estimate repairs, needs hangers on pvc drain pipe
